Manhole Inspection Summary

Manhole # S17EE2041MH

Record Plat: **17EE2** Node: **041** Status: **New Manhole (Not in GIS)** Insp Date: **10/19/06 12:00 AM**

Location Address: **1816 SULGRAVE AVE**

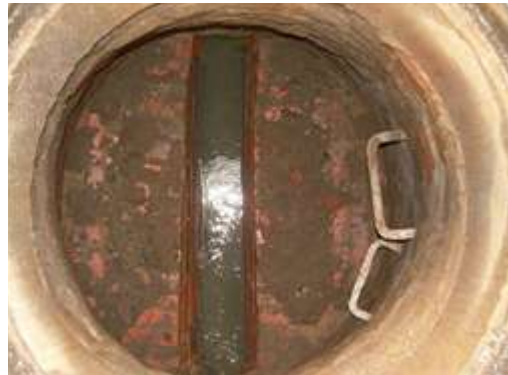
Top View

Evidence of surcharge - Bench debris.

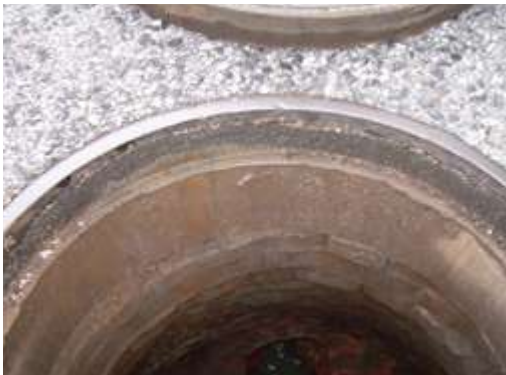
Defect

Frame leaks. Adjustment deterioration and infiltration. Corbel and Barrel infiltration.

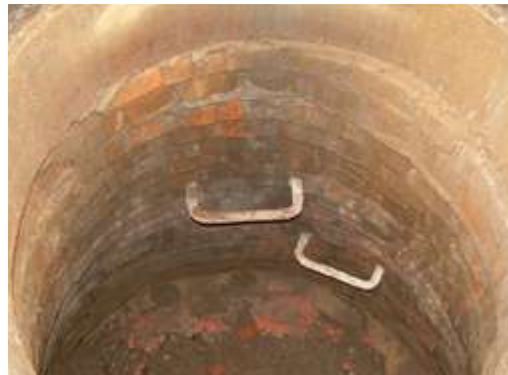
Defect

Frame leaks. Adjustment deterioration and infiltration. Corbel and Barrel infiltration.

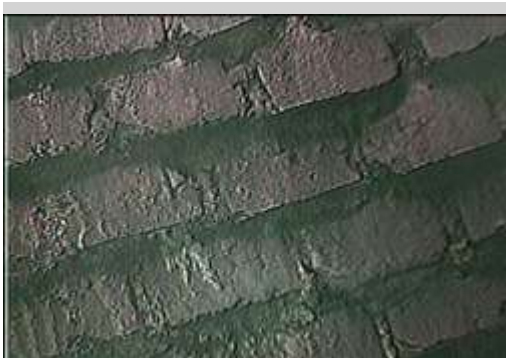
Defect

Corbel and Barrel deterioration and infiltration.

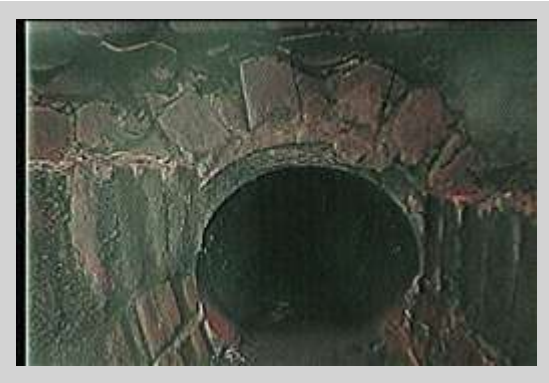
10 in. Circular Gravity Sewer Pipe Out @ 12 O'Clock

Barrel deterioration and infiltration. Channel deterioration.

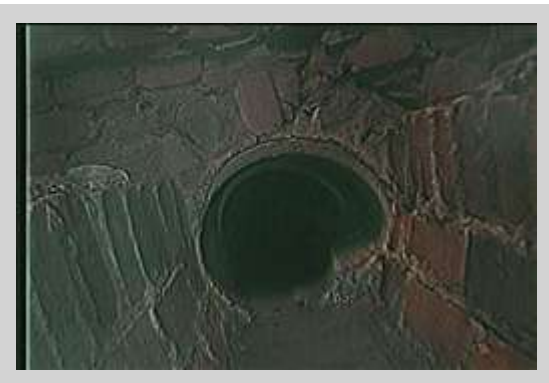
10 in. Circular Gravity Sewer Pipe In @ 6 O'Clock

Barrel deterioration and infiltration. Channel deterioration.
